PAAC Proposal

29! Sculpture Restoration

02.13.2024

CONDITION REPORT

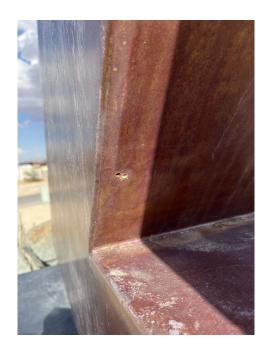
Current State

Overall the sculpture is structurally sound and has a good foundation — a steel base mounted upon a concrete pad. There is no evidence of damage other than cosmetic to the base. The primary issue is the top coating has been eroding from the sun, heat and water runoff. The water dripping down the surface of the elements has dried in place leaving white hard water calcification. In areas where the water has pooled or consistently soaked, the steel has begun to rust. By its nature. Corten steel is meant to rust naturally over time; however, the top coat, most likely applied to preserve it, has in this environment left an uneven surface.

My recommendation is to consult an objects' conservator to review the images and determine (1) if the appearance of the sculpture can be restored by the removal of the peeling top coat, (2) if a top coat should be reapplied or (3) if the sculpture needs to be re-fabricated. Note: it is my opinion that it does not need to be re-fabricated. Instead the Committee should seek to restore the surface and improve the appearance so it is in keeping with the artist's intension.
